Town of Needham  
Memorial Park Building & Grounds Feasibility

May 1, 2017

WINTER STREET ARCHITECTS, INC.

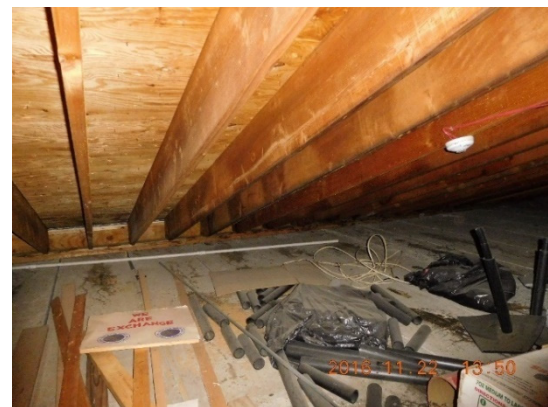
4. ROOF FRAMING AND CONCRETE PLANK ATTIC FLOOR

The west portion of this facility is about 76'-10" wide and 24'-4" deep in plan. This late addition, with the first floor higher than the main workshop floor, houses public bathrooms and other work spaces. One side of this space is enclosed by workshop wall and the other three sides are enclosed by CMU walls bearing on concrete foundation walls. 8" thick hollow core planks span about 24 feet between the CMU walls to create the second floor of this portion. Where measured, the planks bear 4" on the CMU. The planks are neither topped with a topping slab nor is there any connection between the hollow core planks. Also, no positive connections were observed between the hollow core planks and the CMU bearing walls.

- ➔ Repair and repoint masonry cracks
- ➔ Provide positive anchorage at top of masonry walls
- ➔ Connect precast panels together by means of a new 2" topping or other suitable means
- ➔ Provide positive connection between roof diaphragms and masonry walls that act as shear walls

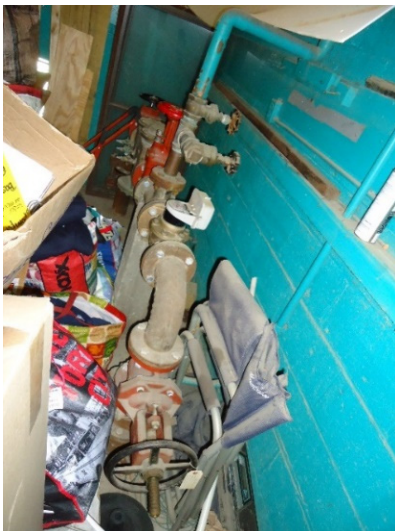
6. WATER SERVICE

Domestic water is supplied underground through a reduced pressure zone backflow preventer and water meter with gate valve for isolation. There is a tap between the backflow preventer and meter, which is most likely for an exterior irrigation system. The water service piping appears to be ductile iron, flanged, and in good condition.

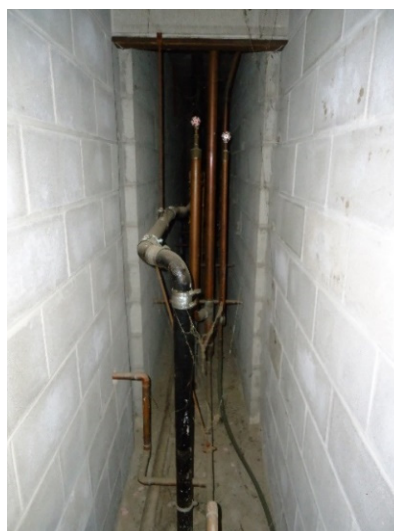
7. PLUMBING CHASE

The piping rises from and returns to below the floor slab, so only the exposed piping scattered throughout the building could be observed and evaluated. The domestic water piping is hard drawn copper tube and appears to be in good condition with no evidence of active leaks. The piping is not insulated, and there appear to be some questionable connections and terminations. There is an irrigation control system located in the concession kitchen area.

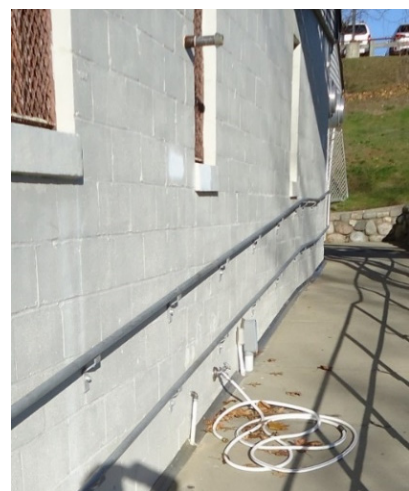
8. UNKNOWN TERMINATION AND PIPE EXITING WALL EXTENDING UNDERGROUND.

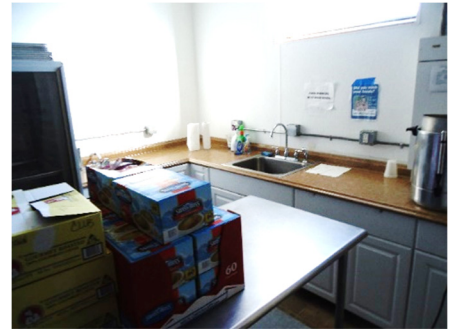
9. CONCESSIONS SINKS

1. The condition of concealed and underground piping could not be observed.
2. One of the concession stand sinks is piped with PVC.
3. The urinals in the men's restroom are not separated with privacy shields.
4. Hose connections are not fitted with vacuum breakers.
5. Unit heater vent piping is not sealed.
6. Unknown hot water storage and delivery temperatures.
7. Unknown flow from public lavatories.
8. Floor drains not equipped with trap primers

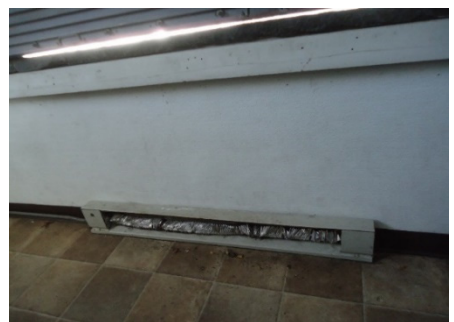
The Kitchen and concession area was observed to be served by an electric baseboard radiation heaters located underneath the concession stand opening. This baseboard radiation was observed to be in damaged condition. The staff bathroom was observed to be unconditioned.

18. DAMAGED ELECTRIC BASEBOARD RADIATION AT CONCESSION AREA (KITCHEN)

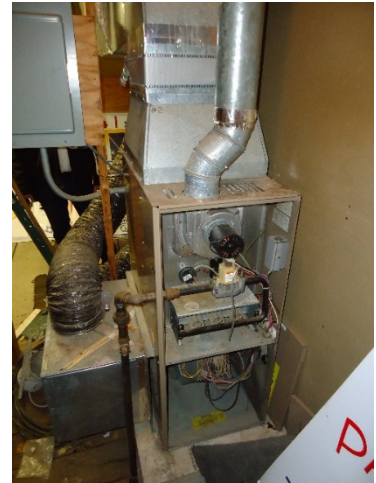
**19. SECOND FLOOR – HEATING ONLY AHU.**

The HVAC systems serving the second floor consist of two (2) air handling units (AHU). One (1) AHU is a heating only unit with a gas fired furnace and serves the storage spaces, hallway, kitchen and restrooms on the second floor. This unit was observed to be old and in deteriorating condition. The supply and return air ductwork associated with this unit was observed to be old and includes flexible ductwork with lengths more than acceptable to industry standards. There was no insulation observed on the sheet metal ducts. The unit is controlled by a wall mounted thermostat. There was no outdoor air component associated with this AHU.

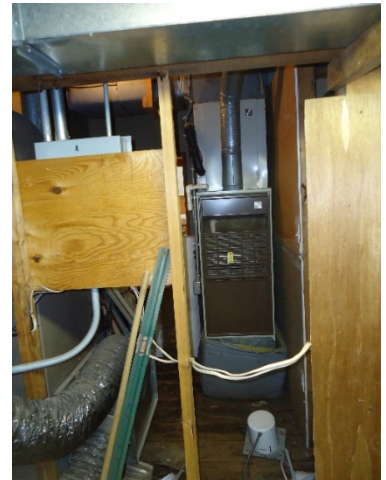
**20. SECOND FLOOR – HVAC AHU**

The second AHU is a cooling and heating unit that consists of a gas fired furnace and a DX split system and serves the meeting rooms. The DX split system includes a DX cooling coil mounted on the furnace and an associated outdoor air cooled condensing unit located at grade. The DX cooling coil is a Carrier, Model #28VQ048030 and is approximately fifteen (15) years old. The furnace and the DX coil were observed to be old and in deteriorating condition. The supply air and return air ductwork was observed to be insulated. The unit is controlled by a wall mounted thermostat. There was no outdoor air component associated with this AHU.

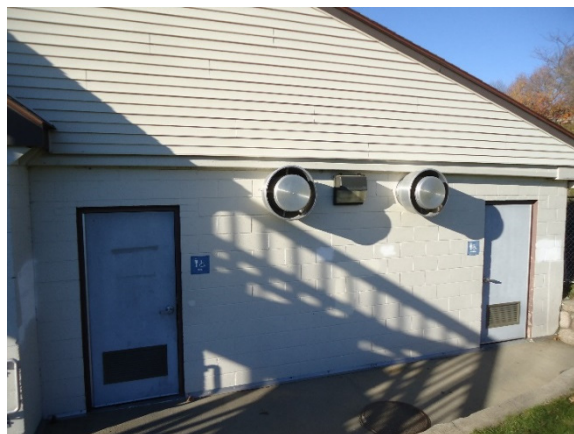
**EXISTING EXHAUST FANS SERVING PUBLIC RESTROOMS**

The two (2) exterior public restrooms were served by electric baseboard radiation which appeared to be in deteriorating condition. Each restroom is served by an exhaust fan mounted on the exterior wall. The exhaust fans are each, Emerson, Model #5DDW106A and were observed to be in fair condition. The exhaust fans are controlled by the wall mounted optical sensor switch that is interlocked with the lights.

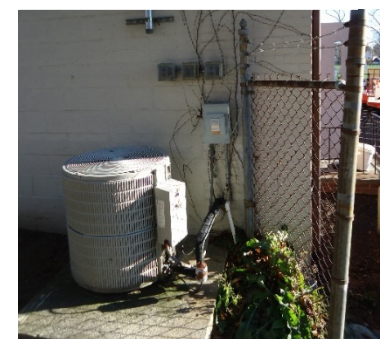
**21. EXISTING AIR COOLED CONDENSER**

The outdoor air cooled condensing unit is a Carrier, Model #38EH048320DL with a 4.0-ton cooling capacity. The condensing unit was observed to be old but in fair condition.
