# **Feasibility Study & Conceptual Design**

## **The Center at the Heights**

**300 Hillside Avenue  
Needham, Massachusetts 02494**

**January 23, 2023**

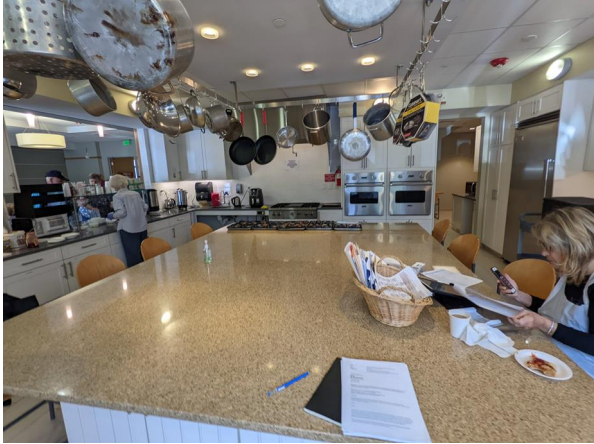
| No. | Photo | Description |
|---|---|---|
| 1. | | <p>An overall picture of the existing Kitchen, showing the existing Serving area, the existing Cooking area, the partial extents of the upper / lower cabinets and countertops, and entrance to the existing Break Room.</p> <p>Note the expansive center island which makes the kitchen less efficient than it could be.</p> |

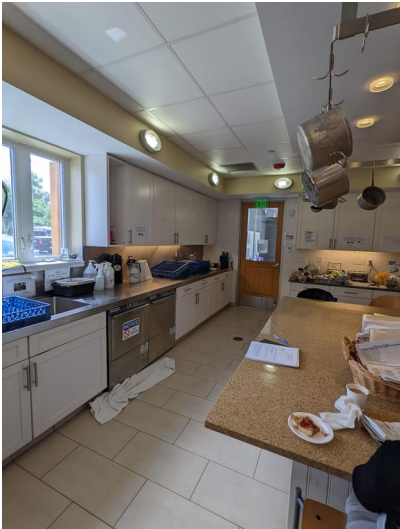
| No. | Photo | Description |
|---|---|---|
| 2. | | <p>Another overall picture of the existing kitchen, showing the existing Washing area, as well as ingress into the space from the existing Cafeteria.</p> <p>Note that the countertop height at the Washing area changes to accommodate the appliances.</p> |

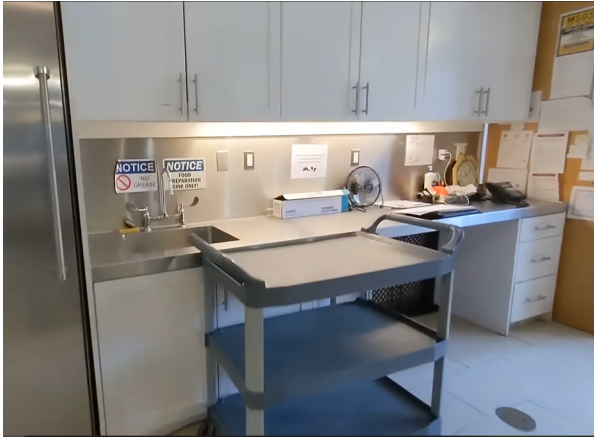
The existing counters, upper cabinets and lower cabinets in the space are ample. However, the majority of the countertops are only 32" high which, makes working on them a challenge for some users. Only the Washing station is the standard 36" high. The existing counter tops are a mixture of materials, with stainless steel along the wet areas, and different types of granite at the Preparation, Cooking and Serving areas.

| No. | Photo | Description |
|---|---|---|
| 3. | | <p>A view of the Preparation area. These countertops are not the standard, comfortable working height.</p> |

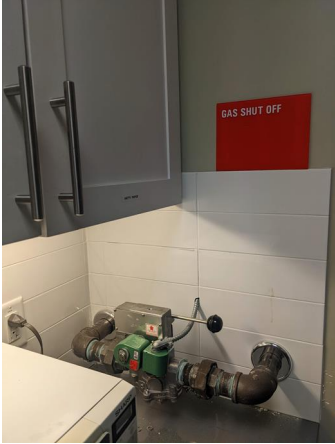
In the existing Break Room (immediately adjacent to this space), there is an existing natural gas shut off. (see pictures 1 and 2), which is typically covered (assumed for protection) by a plywood box and labeled on the wall above. Physically, there are two or three green colored pieces (the "solenoids") that are hot to the touch, whether or not the gas is being used or not. This draws very little power to operate; in fact, it uses low voltage – so there needs to be more investigation into why these solenoids are heating up.

| 4. | | View of the existing gas shut off, located at counter height in proximity to the working surface |

The existing gas shutoff valve, located in the existing Employee Breakroom, was noted to have issues during the site visit. Not only was it located in a non-ideal location – right above the countertop as you walk into to the space – it was also noted to be overheating and was being protected by a makeshift plywood box that was also warm to the touch. The general recommendation would be to remove the gas valve as it is unsafe and move towards an all-electric kitchen.

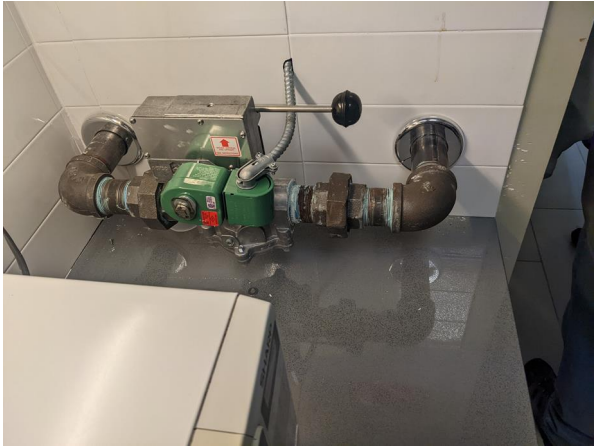
| 5. | | An enlarged picture of the existing gas shut off. Note that the solenoid (colored green) is hot to the touch regardless of whether or not natural gas is being used or not. |

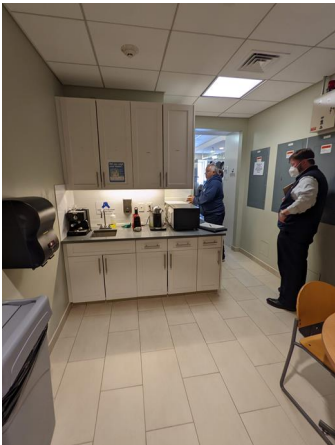
| 6. | | View of the existing Break Room. This space is under utilized in the existing design. |

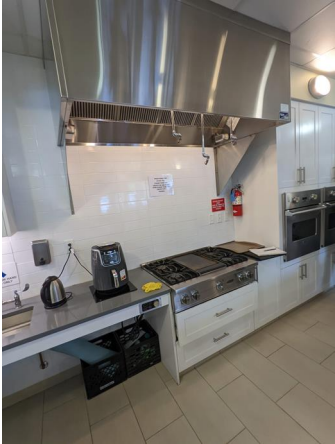
The cooking area is comprised of two (2) small and residential type wall ovens (assumed ventless), a four burner commercial range cooktop and an induction burner. There is a hood above the range, however workers reported that it is too high to catch any rising steam & fumes being emitted from the range.

| 7. | | <p>View of the existing range and exhaust hood, and two existing wall ovens.</p> |

The existing cooking equipment is not adequate for the intended operation. It is hardly used today except for cooking seldom breakfasts. For an operation that will produce one-hundred-sixty meals per day, there will need to be infrastructure changes. For one, the existing cooking equipment will need to be removed and replaced with commercial grade equipment that can handle bulk production such as a tilt skillet, also known as a braising pan, a six-burner range, a griddle, also known as a flat top, and a double stack combi oven. A combi oven, short for combination oven, is a very effective hybrid oven that has both convection and steaming capabilities. It allows the operator to use it in one of three ways, convection only, steam only, or convection and steam. This allows for the ultimate flexibility of the menu. The introduced steam, coupled with smart controls, create consistent product for a wide range of menu items in a foolproof manner. Since the only gas equipment is the existing range, it is recommended to remove the gas and replace with an electric range. This would effectively change the kitchen to be all electric. An all-electric kitchen leans towards a net-zero approach as it will reduce greenhouse emissions caused by equivalent gas equipment. There is a higher upfront cost for electric equipment, however, if reducing the facilities carbon footprint or keeping up with the latest trends is a concern.

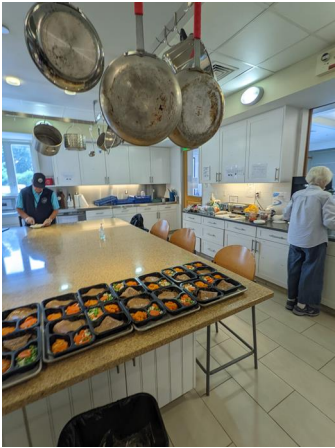
Within the kitchen there is an oversized center island with storage cabinets below, and a provision for interior seating at all sides. At one point, this island was to be used as a teaching space, so many could gather and watch a cooking instructor to replicate their techniques. We were advised by several of the workers that this does not currently happen in this space, and that they do not remember if it was ever used as a teaching space. Furthermore, the large island confines the path of travel greatly and makes working in this area tight and inefficient.

| 8. | | <p>View of the front of the existing kitchen, including the existing center island (with storage below), existing serving window, partial extents of the upper / lower cabinets and existing stainless-steel countertops.</p> <p>These existing countertops are 2-4" lower than the standard, comfortable working height of 36".</p> |

functional solution would be to remove the island and the pot shelving above and replace them with back-to-back stainless-steel worktables and a table mounted over shelf with an integrated utensil and pot rack. The table mounted over shelf should effectively reduce construction costs, since there will not be a need to ceiling mount the unit. The shelf will also provide some storage and a more adequate reach for the operator. The table facing the cooking line will host hot wells for holding food coming off the cooking line and undercounter refrigeration to support the cooking line. Adjacent to the tables will be two heated holding cabinets - one for holding items coming off the cooking line and the other used to requisition to-go orders.

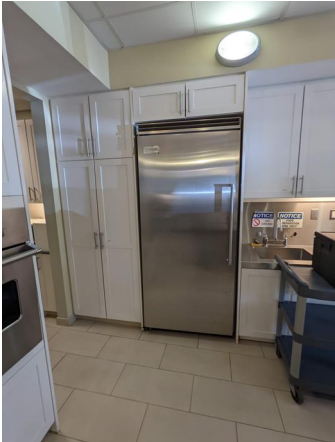
All appliances in the Kitchen are high-end stainless steel, rather than commercial grade. Insufficient refrigeration space is provided by three residential style units with glass shelving, rather than heavy duty wire shelving. There is only one (1), three-door freezer located in the Dry Storage room, which is less than optimal for an existing Kitchen of this size.

| 9. | | <p>Partial rear elevation of the kitchen, showing one of the existing refrigerators, and the entrance to the existing Break Room on the left.</p> |

The current refrigeration is also inadequate. All three refrigerators are residential size and will not be able to handle the demand for larger cooking volumes. The recommendation is to remove the standalone reach-in units and replace with a combination walk-in cooler and freezer box. To achieve this the existing Storage Room will need to be removed and its equipment relocated as this is the ideal location for a walk-in.

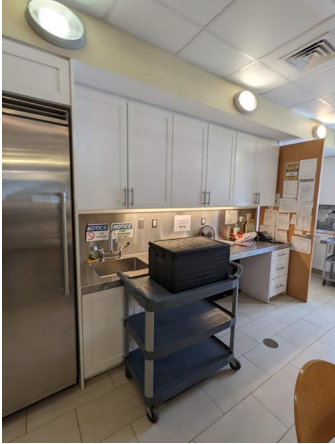
| 10. | | <p>Rear elevation of the existing kitchen, showing the existing refrigerator, cabinetry and countertops, handwashing sink, and entrance to the existing Receiving area to the right.</p> |

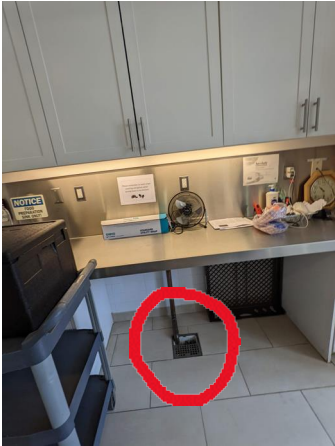
| 11. | | <p>An existing floor sink (circled in red) and drain from an existing handwashing sink on the existing rear countertop.</p> |

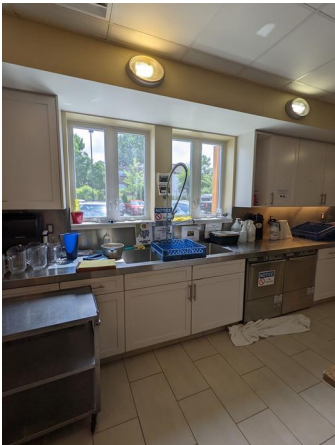
| 12. | | <p>The existing dishwash station, with an integral three compartment sink and two existing commercial dishwashers.</p> |

The existing ware washing area will need to be reworked. The two existing undercounter dishwashers appear to be in good condition and could potentially be reused, if desired, with minimal impact to the proposed plan. However, given the production requested, larger pots and sheet pans will need to be used, meaning a new three-compartment sink that can manage larger pots/pans will be required. If there is a desire to not manually wash larger pots/pans, it is recommended to upgrade the two undercounter dish machines to one stand up ventless dish machine with the proper associated clean and soiled dish tables, as represented in the proposed layout. To conserve on space the pot sink can be incorporated into the clean dish table. With these changes, the grease trap, located in the existing Receiving Area, will likely need to be resized by the plumbing engineer.

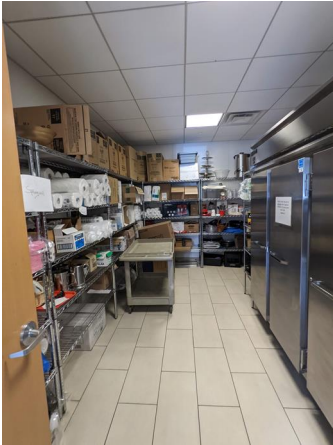
| 13. | | <p>The existing storage area incorporates the existing three door freezer, as well as the existing dry storage.</p> |

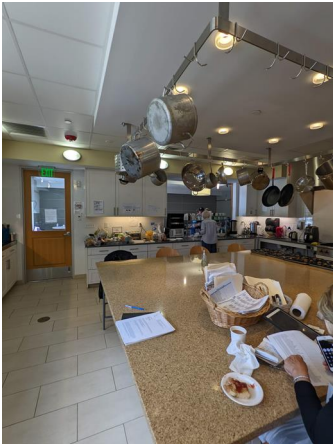
Mimicking the large kitchen island on the ceiling is a painted soffit, with a large pot rack and recessed accent lighting. A soffit encircles the perimeter of the Kitchen and has indirect fixtures mounted to it's face, with provide the majority of the lighting. The remainder of the ceiling is an acoustic tile set within a suspended metal grid. The space does take advantage of what little natural light it receives from a window above the Washing station.

| 14. | | <p>The existing ceiling is comprised of acoustic ceiling panels, as well as gypsum wallboard bulkheads above the cabinets &amp; a gypsum drop ceiling over the island.</p> <p>Lighting is insufficient for the space, with downlights above the island, sconces on the face of the bulkhead and task lighting below the upper cabinets.</p> |

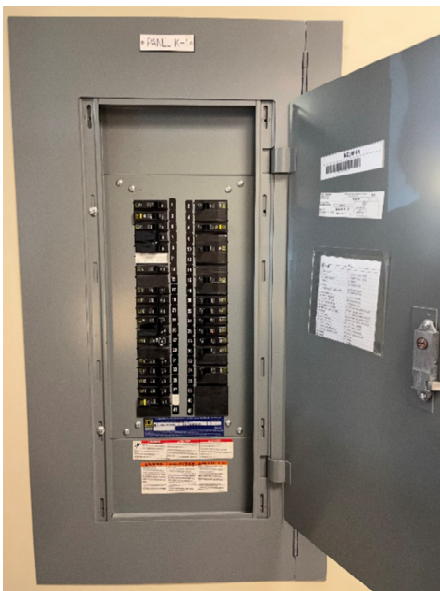
***Existing Kitchen Panel***

Condition: The general condition of the electrical equipment was observed to be in good condition.

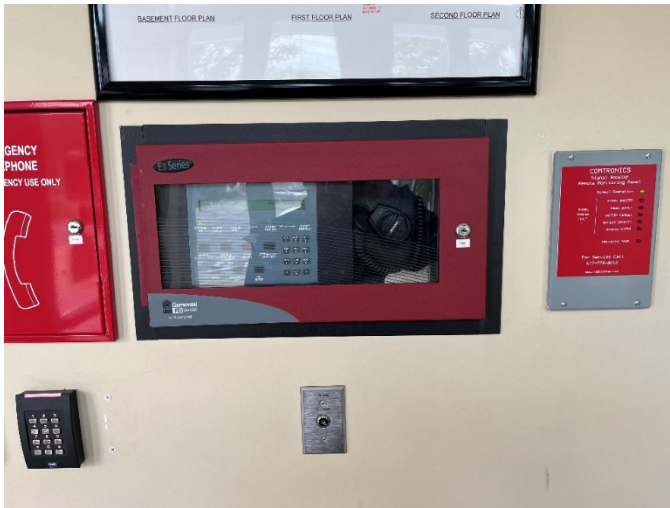
***Existing Fire Alarm Control Panel***

The facility is equipped with an addressable fire alarm system. The system is a Gamewell FCI E3 Series. The system appeared to be installed in accordance with NFPA 72 National Fire Alarm Code, Fire Protection and Life Safety Systems, ADA and Town of Needham Code and Bylaws for Life Safety and Fire Alarm
