Town of Needham  
Memorial Park Building & Grounds Feasibility

May 1, 2017

WINTER STREET ARCHITECTS, INC.

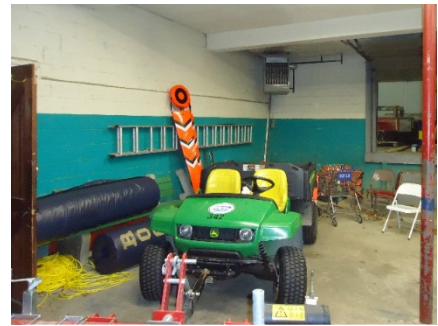
15. GAS FIRE UNIT HEATER-CART GARAGE

The HVAC systems serving the first floor consist of gas fired unit heaters (UH) and electric baseboard radiation. The two (2) garage spaces at the front of the building have one (1) gas fired unit heater (UH) each. The UHs are each Modine, Model #PDP175AE0130 with an input capacity of 175,000 Btuh. The UHs are close to five (5) years old and were observed to be in fair condition. The garage and storage spaces at the rear of the building do not have heating or ventilation equipment.
